**Ecology and Condition of South Twin Lake,
Town of Livingston, Columbia County, New York**

Report to the Twin Lakes Association

18 June 2019

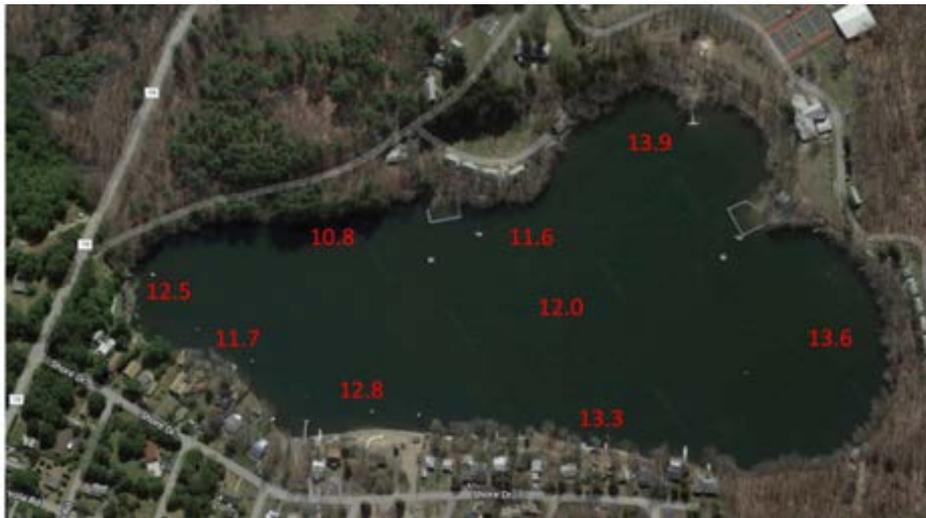
Figure 4. Optical brightener measurements (RFU) for each area of the lake. The numbers around the perimeter of the lake are averages of a number of measurements that were taken along that stretch of the shoreline. The value for the middle of the lake is a single measurement. The difference between the lowest value along the forested edge on the top left of the map, 10.8 RFU, and the embayment at 13.9 is equivalent to almost 1 ppm (part per million) of Tide detergent based on a serial addition experiment with lake water (results not shown). Northeast is at the left of the map.

For South Twin Lake, septic systems are likely a source of nutrients. The houses along Shore Drive and in the surrounding neighborhood are close together, and some are close to the lake, so their septic systems may not have enough space for the leach fields to work properly. In addition, some of the soil types around the lake are not ideal for septic systems. Specifically, the soil type marked NbC in Figure 3 (see caption for description) is not ideal because of a shallow depth to bedrock and restricted permeability (Soil Survey Staff, no date). Septic systems in that soil type may require a lot of maintenance and they may not work well (Soil Survey Staff, no date). The steepness of the land along the shoreline may further “short circuit” septic systems. To look for evidence of leaking septic systems, we measured the presence of optical brighteners (OBs) around the lake (Dubber and Gill, 2017; Tavares et al., 2008). OBs are compounds found in many laundry detergents and other personal care products that are used to indicate human water use. OB measurements from around the shoreline of the lake are shown in Figure 4. The south end of the lake had higher values than other parts of the lake, although the differences were small. The results suggest some generalized impact of leaky septic systems, but no particular hotspot was found with the shoreline survey on 17 October 2018.

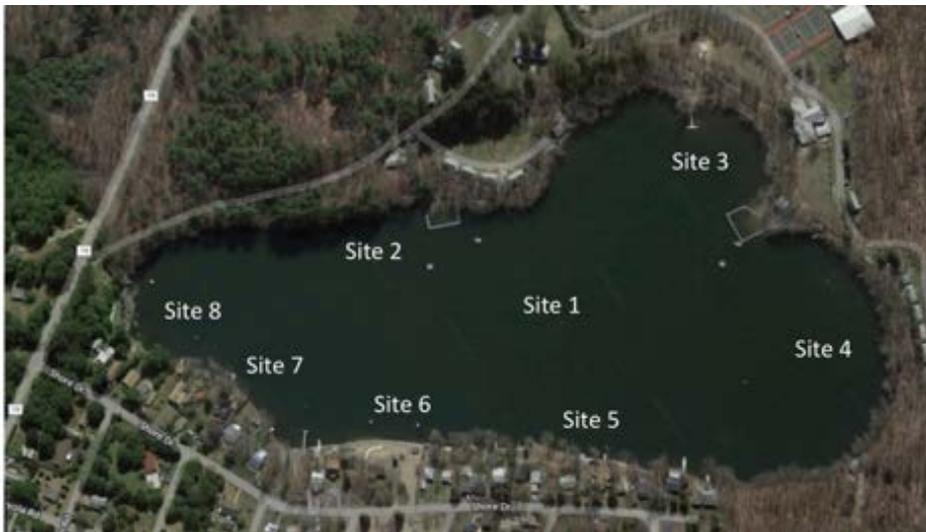
Figure 5. Sites where IDEXX bacteria testing was done on 30 October 2018. Northeast is at the left.

In addition to OBs, we also tested for bacteria that indicate contamination from human waste (Figure 4; Table 2). Samples taken on 30 October 2018 showed that most areas of the lake had low levels of these bacteria, below the detection limit in most cases. Fecal bacteria were detected, but not at alarming levels, at the downwind (northeast) end of the lake as well as the higher use areas at the community beach and the camp. The embayment by the camp had detectable levels of all three kinds of bacteria tested. OBs were also higher there, suggesting that might be a problem area worth monitoring further, especially in the summer when bacteria grow faster and there is more use of the lake.
